THE ARCING PHENOMENON IN ELECTRICAL DISCHARGE MACHINING AND ITS EFFECTS  
ON THE MACHINING PROCESS

E. W. Bartel and T.O. Hockenberry

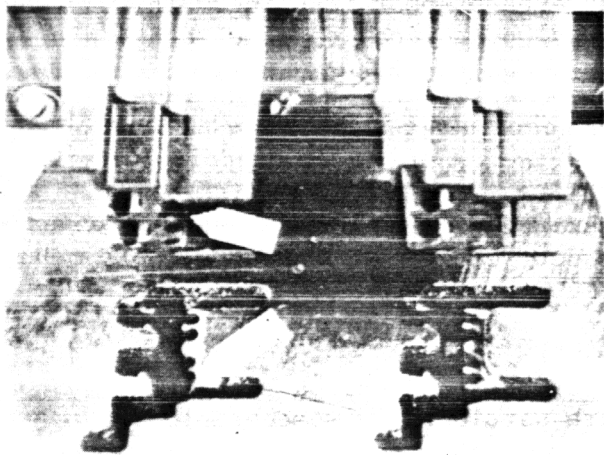
successive machining discharges occur at the same physical location on the workpiece surface. Damage can be very expensive even if as few as two or three discharges occur in that same spot. A succession of machining pulses in the same location can destroy the surface finish of the workpiece by overheating and thereby necessitate an expensive hand re-finishing process. Typical workpiece damage from arcing is shown in Figure 1.

Fig. 1-Die Opening in an Aluminum Extrusion Die. The Cavities were Machined Simultaneously in a Single Operation with two Identical Electrodes. One Cavity developed a Carbon Growth and suffered Damage - Note the Missing Protrusion (Left Arrows) in the Left Cavity, and Tool Electrode.

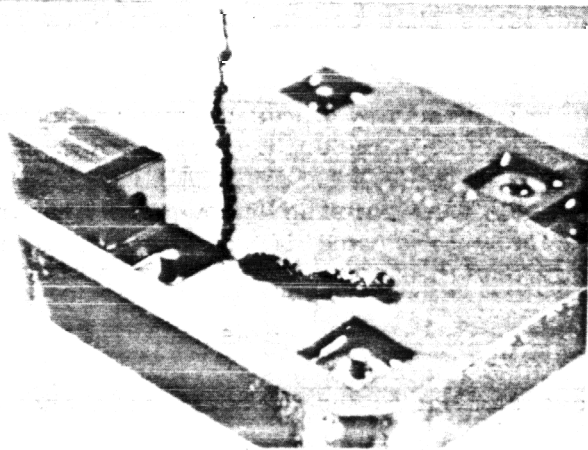
Fig. 2-Carbon Growth which Developed in a Commercial EDM Machine under Normal Operation. The Vertical Growth is Attached to the Steel Workpiece (Anode). The Carbon Growth lying Horizontal was forced attached to the Graphite Electrode (Cathode).

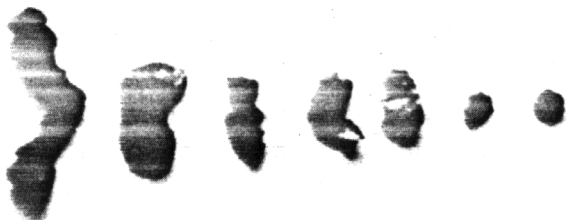
Fig. 3-Typical Coking Growths of Varying Size obtained during a Normal EDM Operation.

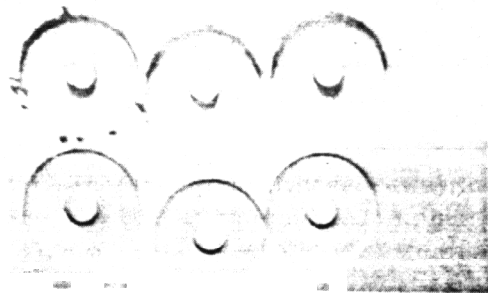
The second type usually takes the form shown in several of the machined cavities in Figure 4. Because of the rough burred appearance of the leading edge of the machined cavities, most EDM operators term this form of arcing as "burring". In a severe case of "burring" a workpiece can be extensively damaged and possibly destroyed. More often the damage is less severe and expensive hand finishing is required to salvage the workpiece. Additional information regarding "burring" will be presented later in this paper.

Fig. 4-Example of 'the Damage Typically found When "Burring" has taken Place on a Steel Workpiece.

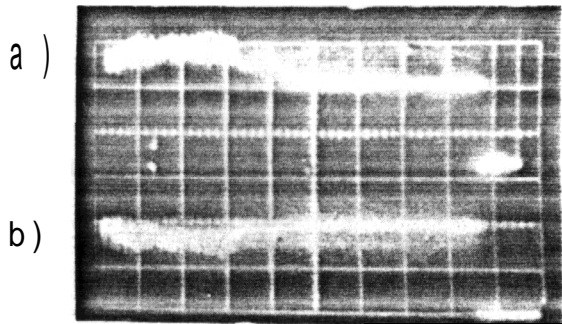
There are several other properties of the coking condition that distinguish it from normal machine operation besides the obvious ones mentioned previously. When coking is occurring in the gap spacing, there is a marked decrease in the gap voltage of each machining pulse, an increase in the discharge current, and a remarkably stable machine operation. The oscillogram in Figure 5 shows a gap voltage and current waveform that exhibits the abrupt change that occurs when the arcing condition starts during the machining pulse. Referring to Fig. 5, the gap current and voltage waveforms are smooth and fairly noise-free after coking has begun compared to the earlier portion of the waveshape where there is no coking. When coking develops, consecutive current discharges occur in the same general location, causing an accumulative heating effect, which, apparently lowers the gap machining voltage. This effect causes higher currents and the formation of excessive amounts of machining debris in one particular location.

Fig. 5- Oscillographs of the Machining Current and Voltage Waveforms that shows a Standard Machining Pulse converting to a Coking Pulse.

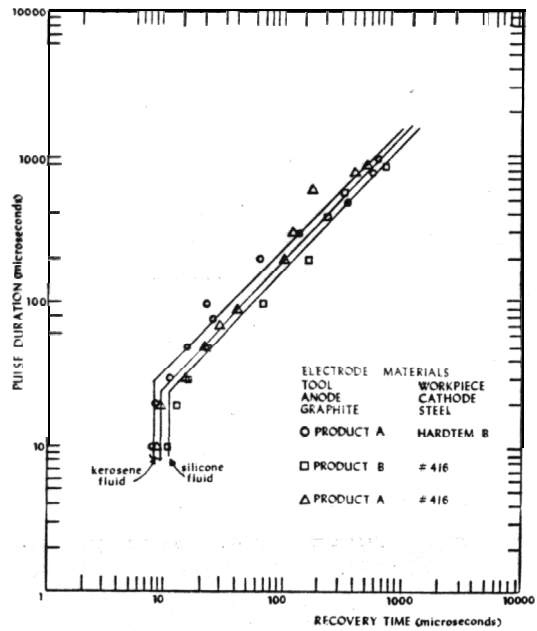
Fig. 6-Recovery Times for Two Graphite Materials as the Anode and Steel as the Cathode in the Indicated Dielectric Fluid With a Coking Condition.

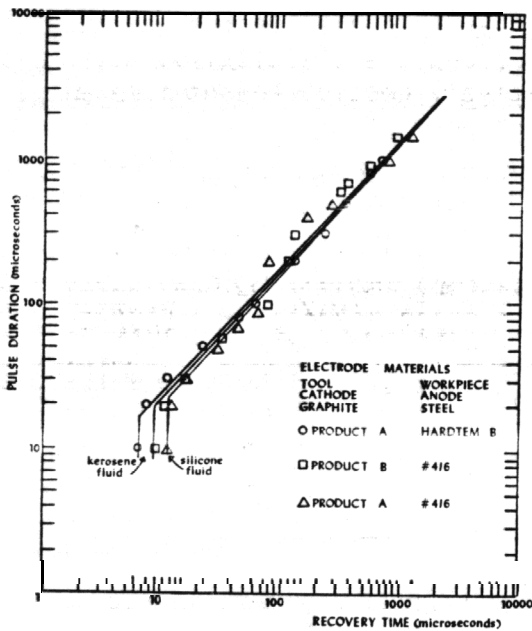
Fig. 7-Recovery Times for Two Graphite Materials as the Cathode and Steel as the Anode in the Indicated Dielectric Fluid With a Coking Condition.

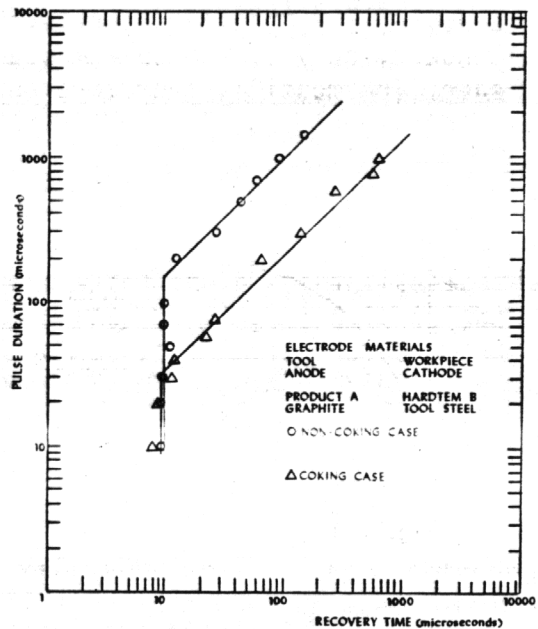
The coking condition was investigated by using several different workpiece materials and various tool graphites immersed in different EDM fluids, with both a tool cathode and tool anode configuration. The recovery time results are very similar in all cases tested. This similarity can be attributed to the fact that when coking occurs the machining discharge column terminates on the carbon growth instead of on the original electrode surfaces. Since the composition of the electrode termini of the discharge are similar, if not the same, the results would be expected to be similar. The tool anode and tool cathode polarity results using Product A on Hardtem B with a kerosene based dielectric fluid, Product B on 8416 Steel with a kerosene based dielectric fluid and Product A on #416 Steel with pure silicone dielectric fluid, are shown in Figures 6 and 7. A comparison of these results shows that they were very similar and all exhibited a constantly increasing recovery time with increasing pulse duration. It may be noted that the recovery times are much longer than those found under normal non-coking conditions. This increase is demonstrated by Figure 8 which shows a comparison of normal and coking recovery times.

Fig. 8-Recovery Times for Product A Graphite as the Anode on Hardtem B Tool Steel as the Cathode in a Kerosene Based Dielectric Fluid with and without a Coking Condition.
